Manhole Inspection Summary

Manhole # S21G1_010MH

Location Address: **2500 puget st**

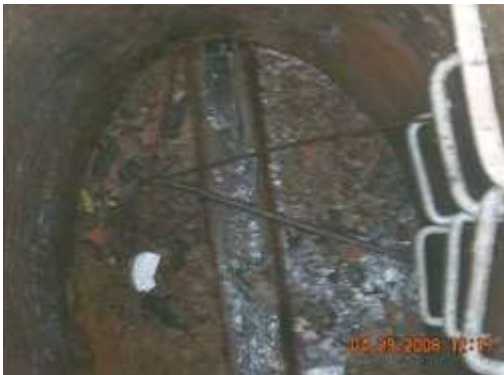
Defect 3

Condition: ☐ Sound ☐ Cracked ☐ Root Intrusion ☐ Deteriorated ☐ Leaks ☒ **Debris**

debris on bench

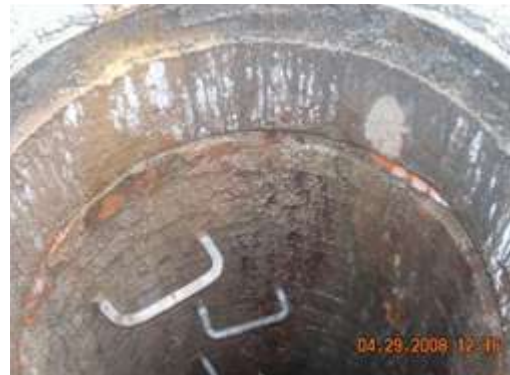
Defect 2

Infiltration: ☐ None ☒ **Joint** ☐ Cracks ☐ Mortar ☐ Roots ☐ Wall

infiltration @ chimney joint; inflow evidence

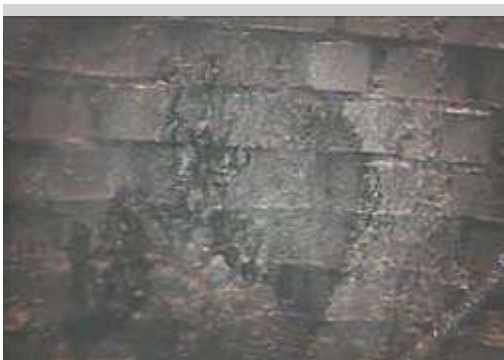
Defect 1

Infiltration: ☐ None ☐ Joint ☐ Cracks ☐ Mortar ☐ Roots ☒ **Wall**

infiltration @ barrel wall

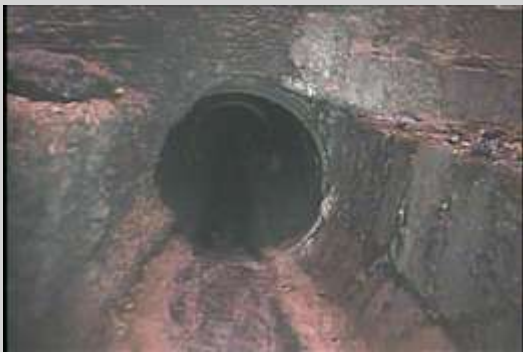
12 O'Clock Outflow

Pipe Height: **8.4** (in.) Rod and Bar (Angled)
Pipe Material: **Clay** ☐ Pipe Lined
Invert Depth: **10.95** (ft.) Flow Characteristics: **Slow**
Deposits: ☐ None ☒ **Mud** ☐ Sludge ☐ Debris ☐ Grease
Silt Depth: **2** (in.) Deposits Extent: **Light**
Infiltration: **None** Pipe Seal Cond: **Unknown**
